9 Habitat Survey

David Zafft and Kevin Gelwicks

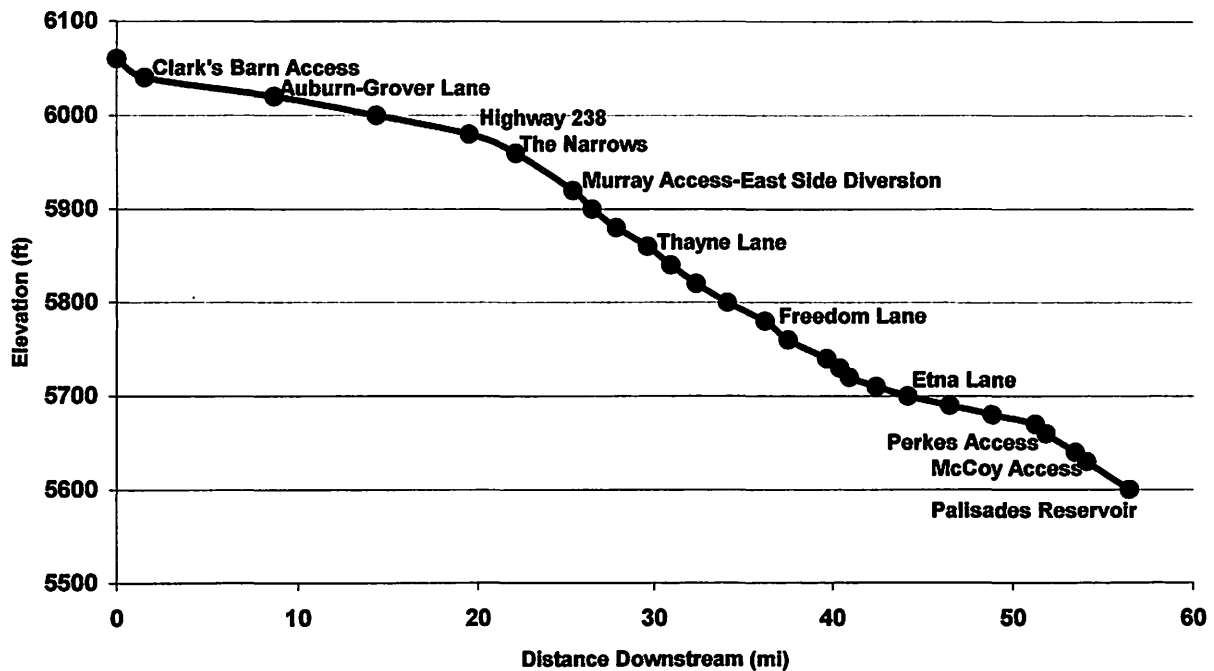
Figure 9-2. Gradient profile of the mainstem Salt River from Afton, Wyoming to Palisades Reservoir. Annotated locations coincide with those on Figure 9-1.

Just downstream of the Highway 238 Bridge, gradient increases as the river enters The Narrows. The average slope is about 0.22% between Highway 238 and Etna Lane. The river is braided in this reach with numerous secondary channels, sloughs and oxbow lakes. Riparian vegetation in and just downstream of The Narrows is still dominated by willows, but Douglas fir, cottonwood and aspen are also present along the river. As the river emerges into the lower valley, trees become less abundant near the river and riparian vegetation is again composed of willows, sedges and grasses. Short reaches of highly braided channels are common between the Murray Access Area and Etna Lane (Figure 9-2).

Between Etna Lane and the Perkes Access Area, slope decreases to 0.10% and the river meanders extensively. The river becomes wider and shallower in the middle of this reach with very little willow coverage and extensive eroding banks. In the vicinity of the Perkes Access Area, slope increases and willow coverage becomes extensive. The slope averages 0.24% in the lower reach between the Perkes Access Area and Palisades Reservoir (Figure 9-2).

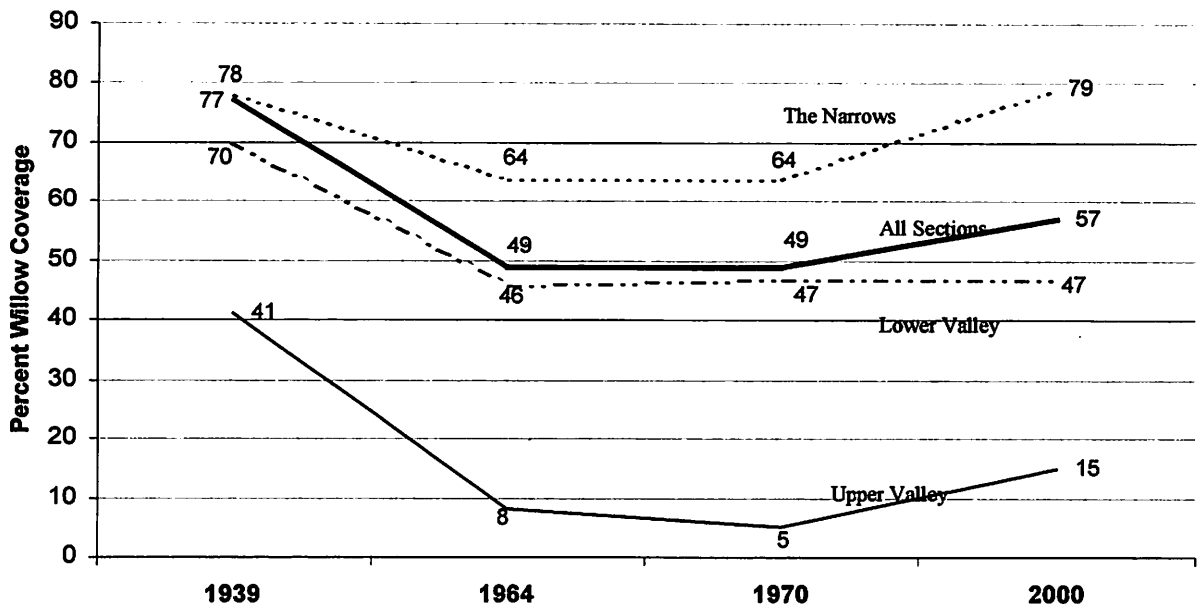
Figure 9-4. Trends in willow abundance at three sections of the Salt River and the average trend for all sections. Upper River is Clark's Barn to Auburn-Grover Lane. Narrows is Highway 238 to Thayne Lane. Lower Valley is Freedom Lane to the McCoy Access Area.

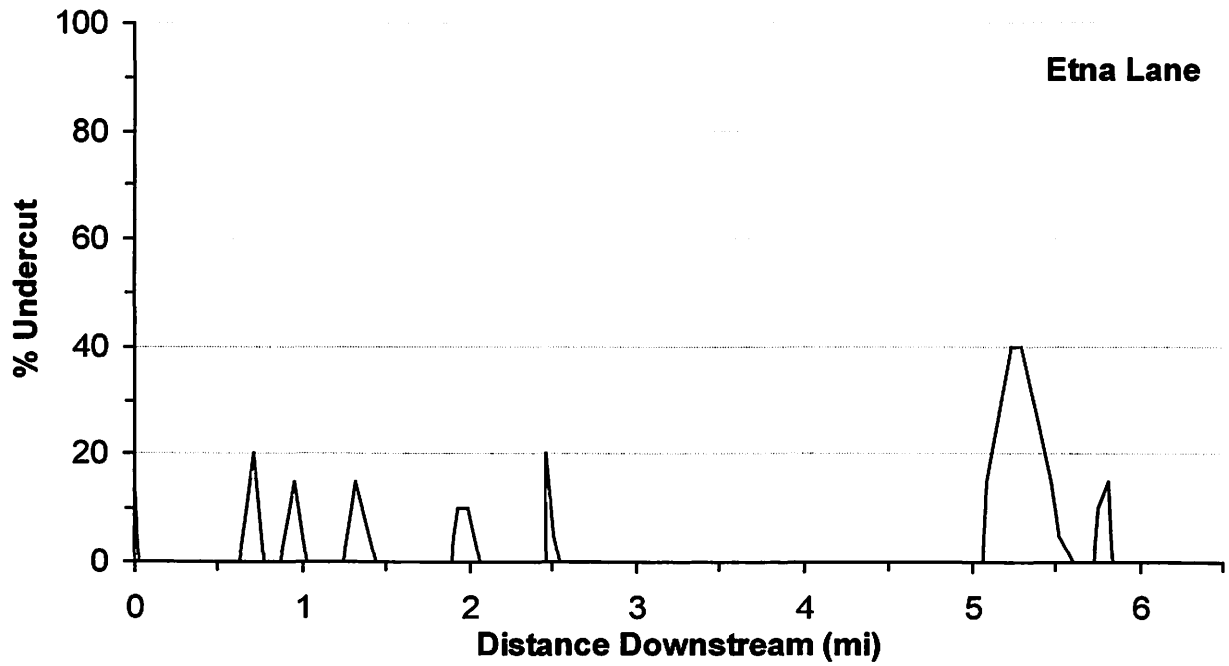
Appendix 9-A Continued

Appendix 9-A. Distribution of undercut banks in four sections of the Salt River in 1998-1999. Distribution is presented from the upstream end of the study section to the downstream end. Primary channel only with backwaters excluded.

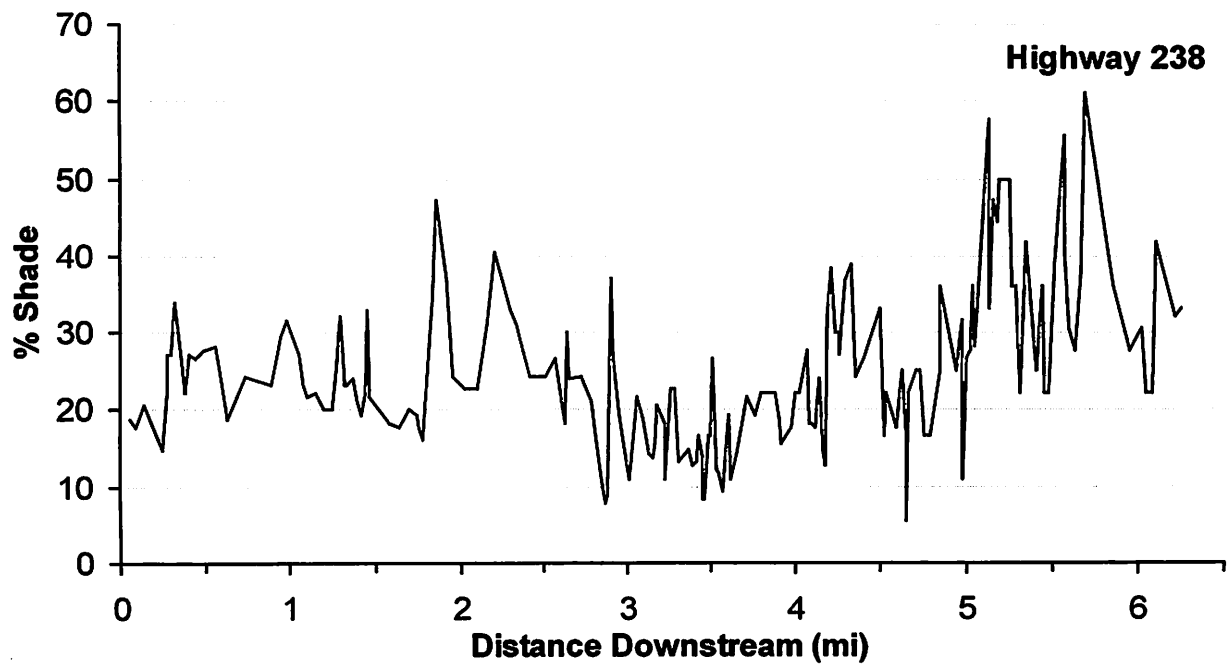
Appendix 9-B cont.

Appendix 9-B. Distribution of shade in four sections of the Salt River in 1998-1999. Distribution is presented from the upstream end of the study section to the downstream end. Primary channel only.

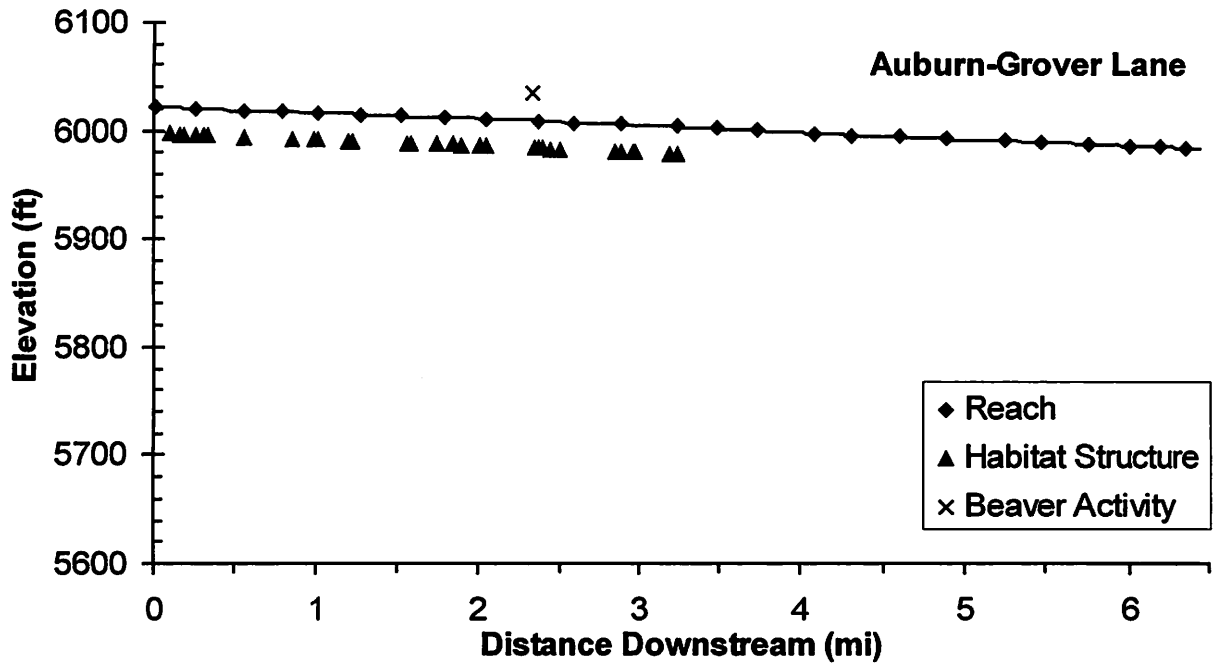
Appendix 9-C Continued

Appendix 9-C. Distribution of habitat structures and beaver activity within the primary channel of four sections of the Salt River in 1998-1999. Distribution is presented from the upstream end of the study section to the downstream end.

Much effort has been expended over the years to stabilize the channel in this reach with riprap and revetments, but the treated channels are soon abandoned. Few structures were found in the primary channel in 1998 and 1999 (Appendix C). A number of major channel changes occurred within this section between 1995 and 2000. The changes at one site were so severe that the direction of flow within the channel was reversed.

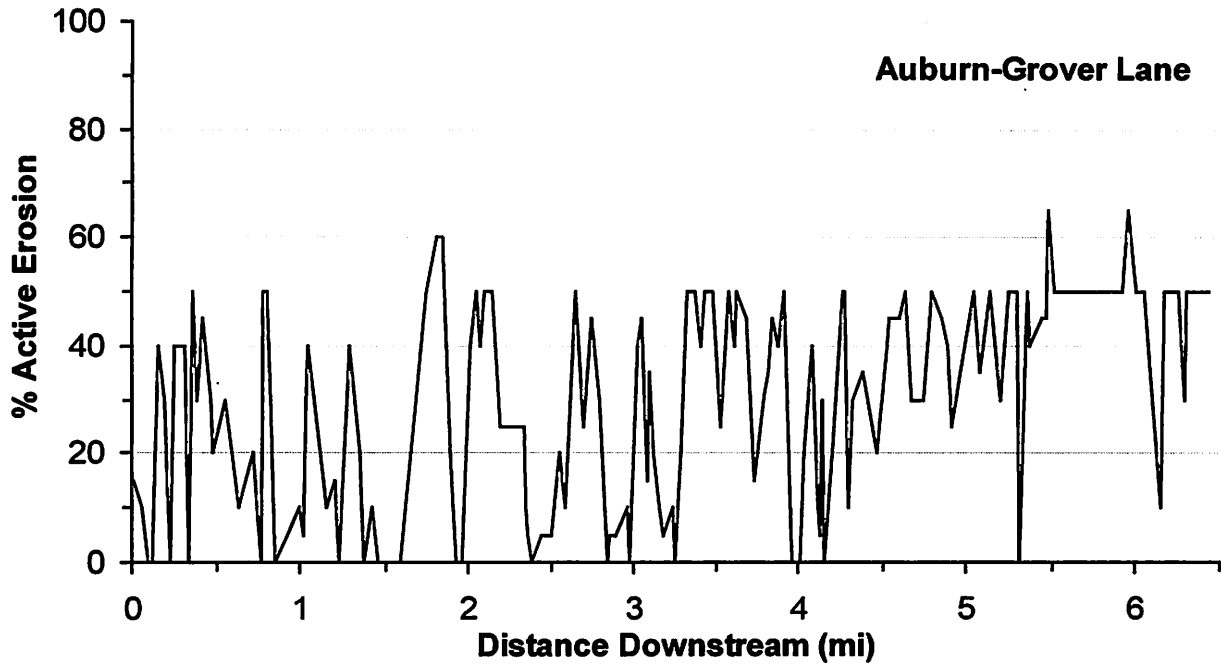
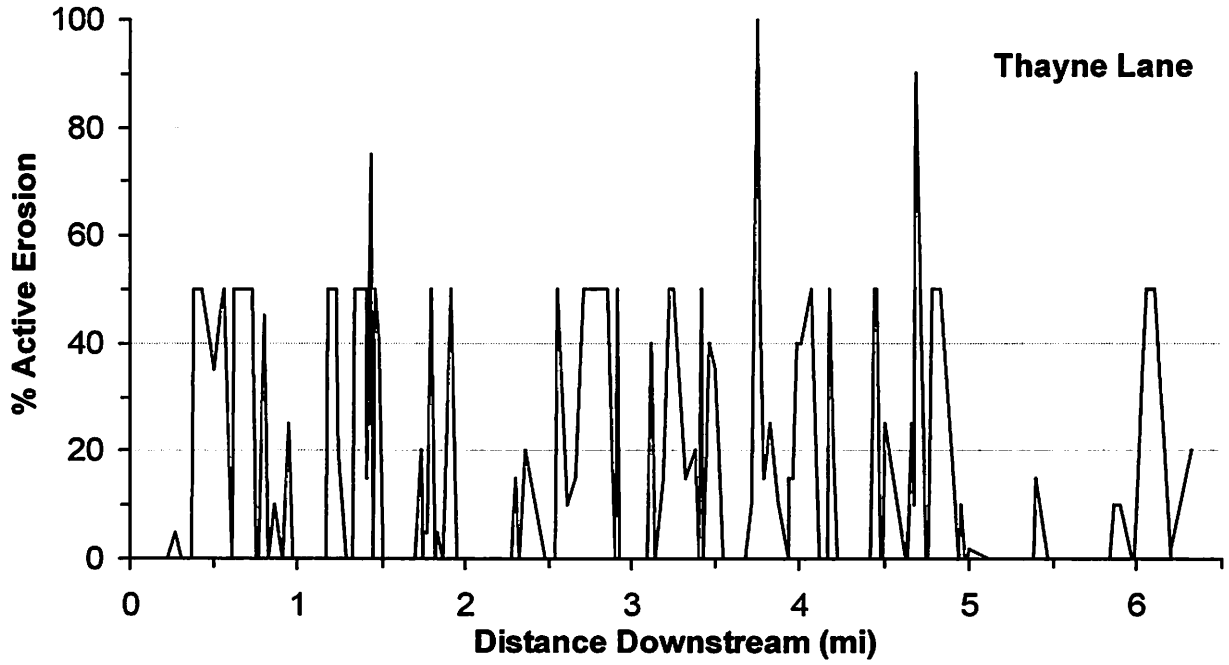
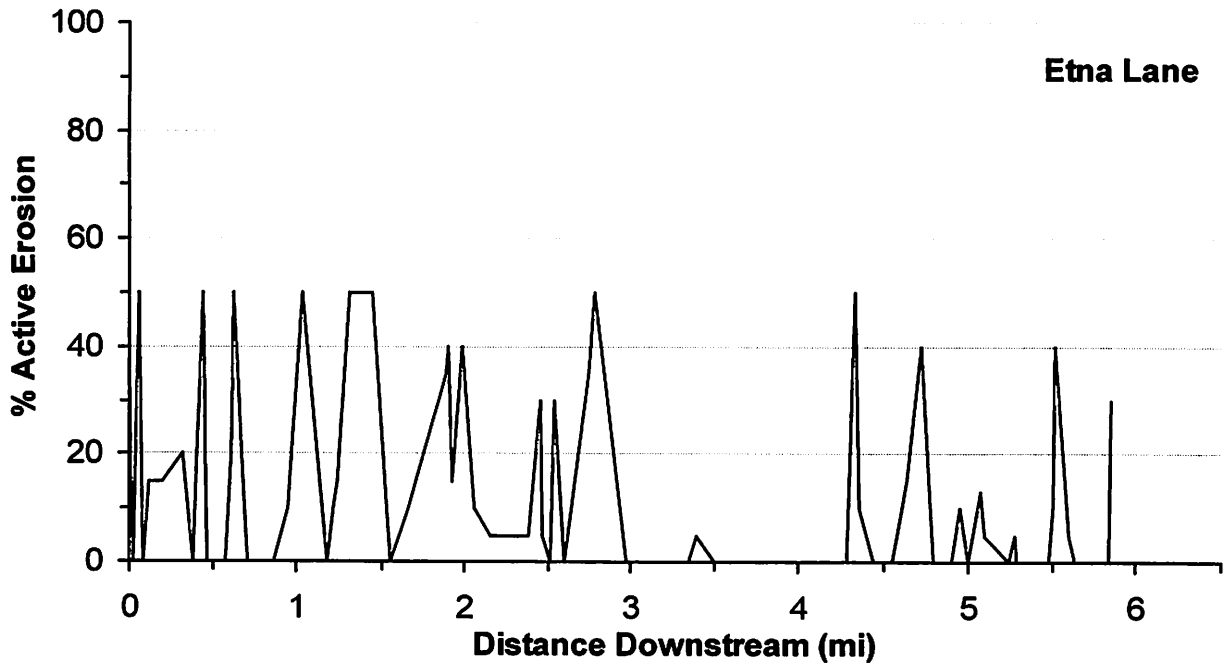
Appendix 9-D Continued

Appendix 9-D. Distribution of active erosion in four sections of the Salt River in 1998-1999. Distribution is presented from the upstream end of the study section to the downstream end. Primary channel only.

Eroding banks within the primary channel ranged from 4% in the Highway 238 section to 30% in the Auburn-Grover Lane section. The Thayne Lane and Etna Lane sections were intermediate with 12% and 17% of the primary channel banks eroding, respectively. Large wood was most abundant in the Etna Lane study section; however, nearly all of the large wood within the Etna Lane and Auburn-Grover Lane sections was revetments. The large wood at the Highway 238 and Thayne Lane sections was usually conifers recruited from the surrounding hill slopes of The Narrows.

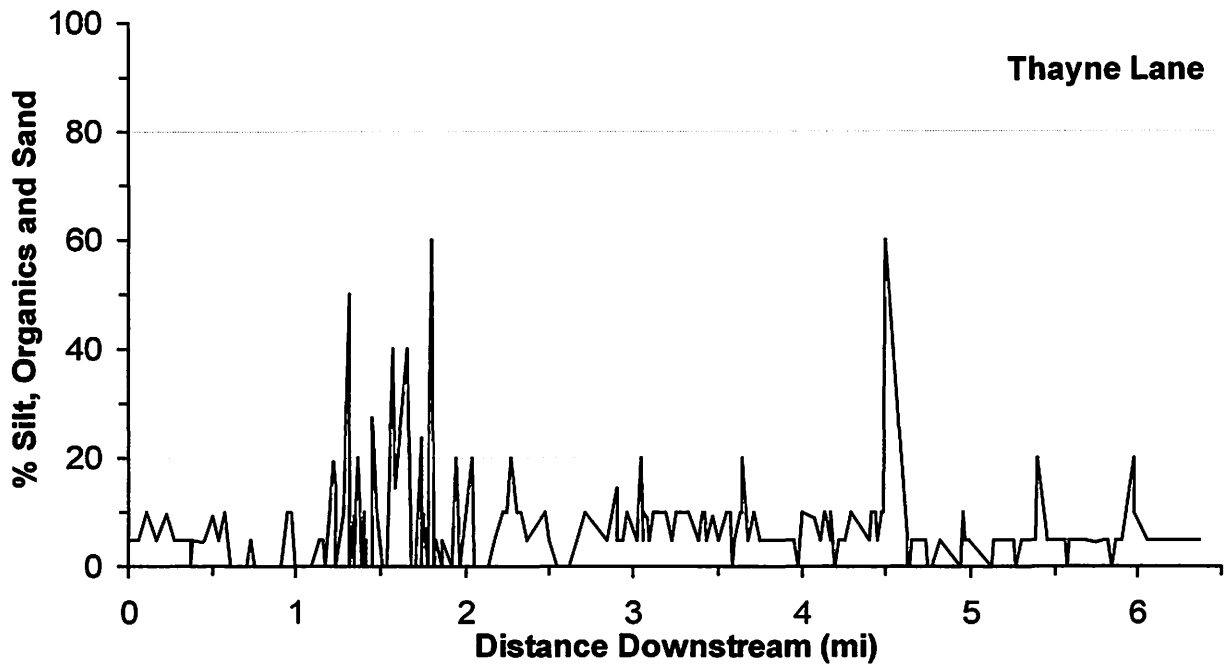
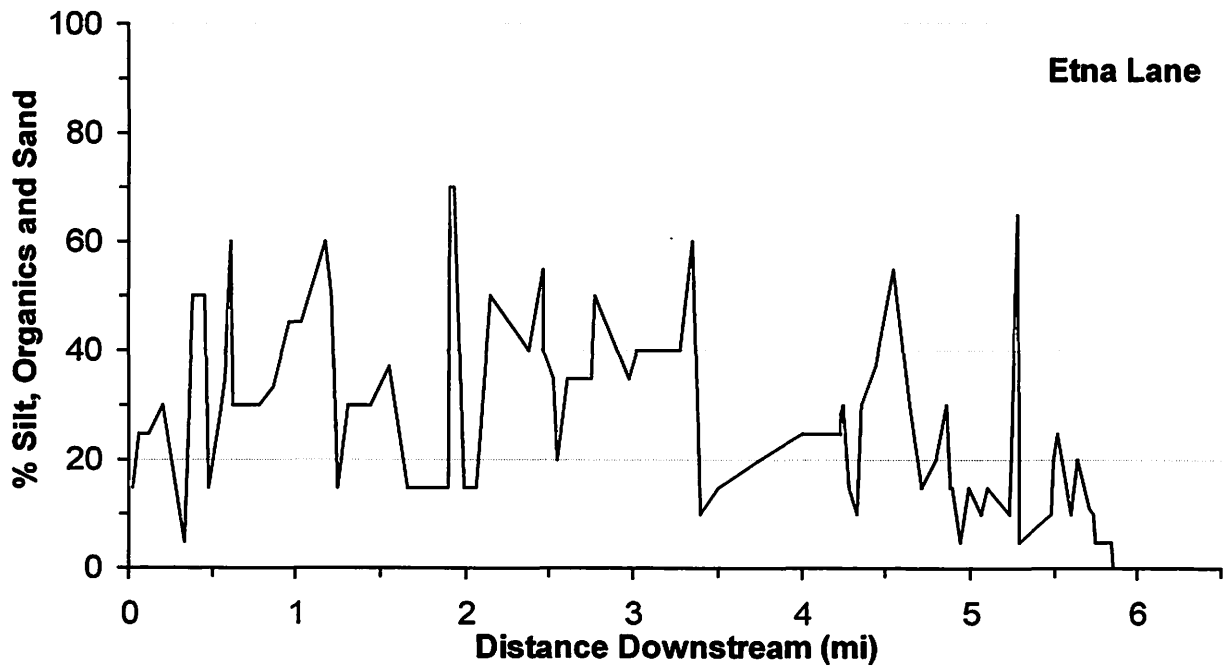
Appendix 9-E Continued

Appendix 9-E. Distribution of fine sediments within the primary channel of four sections of the Salt River in 1998-1999. Distribution is presented from the upstream end of the study section to the downstream end. Backwaters are excluded.
