Subject: Salt River Subbasin Assessment and Total Maximum Daily Load – 2018

Hydrologic Unit Code 17040105

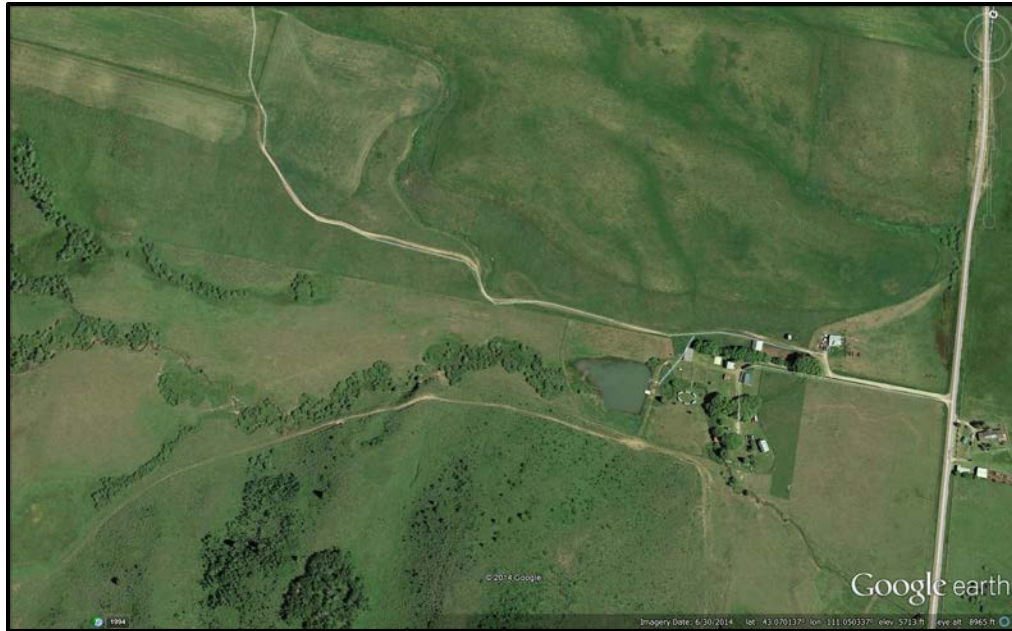
Figure 4. Dam and pond on Newswander Canyon (ID17040105SK001_02b).

Newswander Canyon (ID17040105SK001_02b) is also in Category 4c for physical substrate habitat alterations, which is appropriate because this stream is dammed and physically altered (Figure 4).

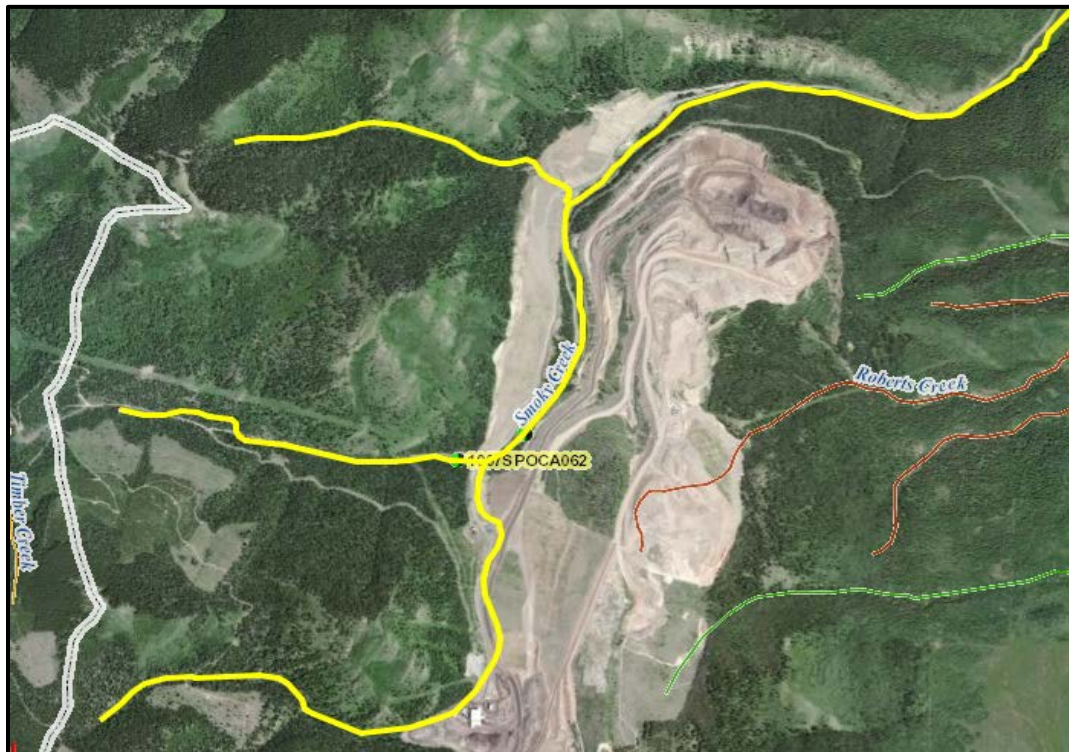
Figure 7. Smoky Creek (ID17040105SK007_02c) in its upper reaches. Smoky Canyon Mine has altered the physical habitat of this AU.

Smoky Creek (ID17040105SK007_02c) is in Category 4c for physical substrate habitat alterations, which is appropriate as the upper portion of the drainage is altered by the Smoky Canyon Mine (Figure 7). This AU should remain in Category 4c for physical substrate habitat alterations.

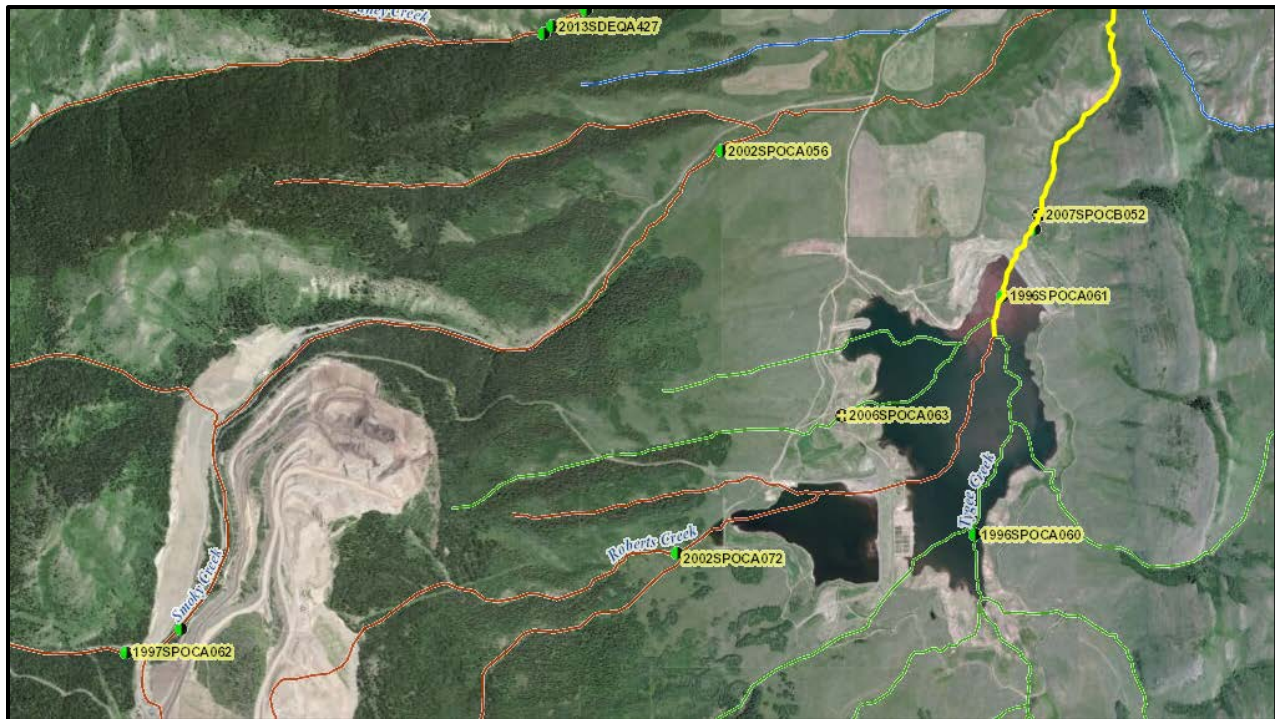
Figure 8. Tygee Creek (ID17040105SK007_03) is highlighted in yellow. Originally, the 3rd-order segment of Tygee Creek began at the confluence of Roberts Creek and the 2nd-order segment of Tygee Creek. This area is now under a pond used for milling of phosphate ore at the Smoky Canyon Mine. Tygee Creek is channelized around the pond.

Tygee Creek (ID17040105SK007_03) is in Category 4c for physical substrate habitat alterations and low-flow alterations. These listings are appropriate. At the very upper portion of the AU, the creek is channelized and diverted around a man-made pond used in milling of phosphate ore at the Smoky Canyon Mine (Figure 8). Lower in the AU, the creek is diverted for agriculture.

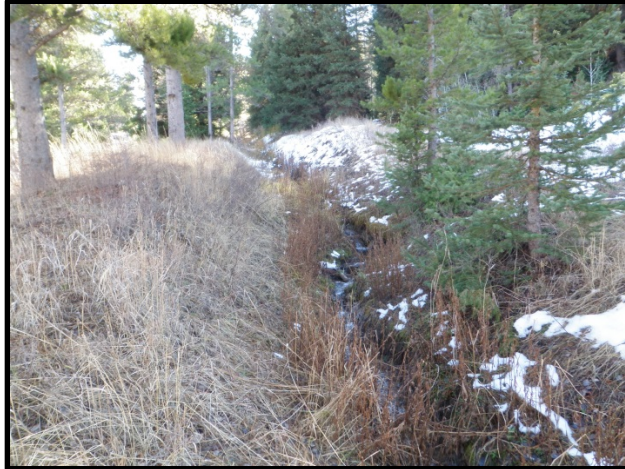
Houtz Creek—channelized lower 100 meters.

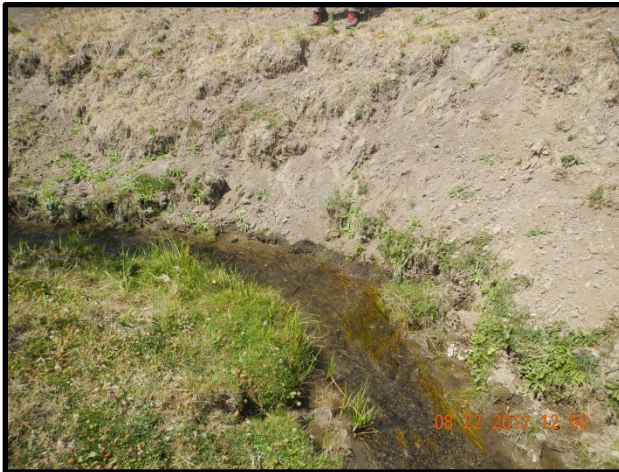
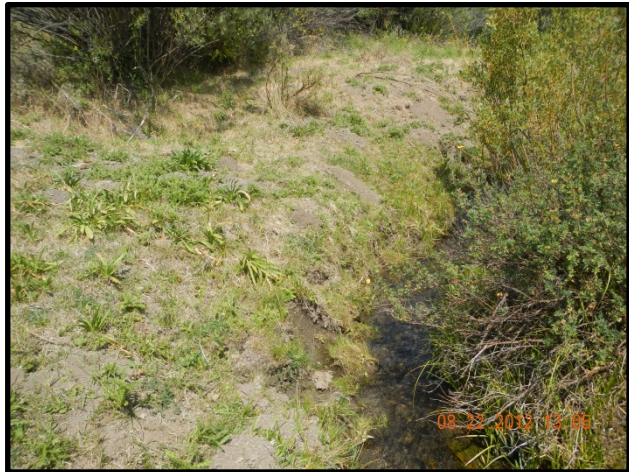
Smoky Creek—examples of unstable and trampled streambanks.

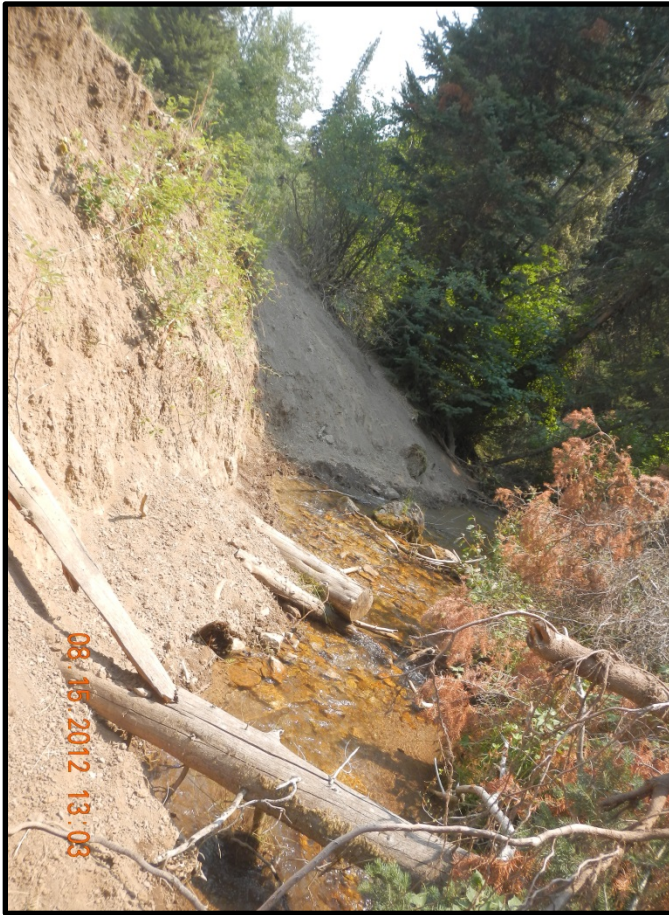
Draney Creek—example of unstable streambank.

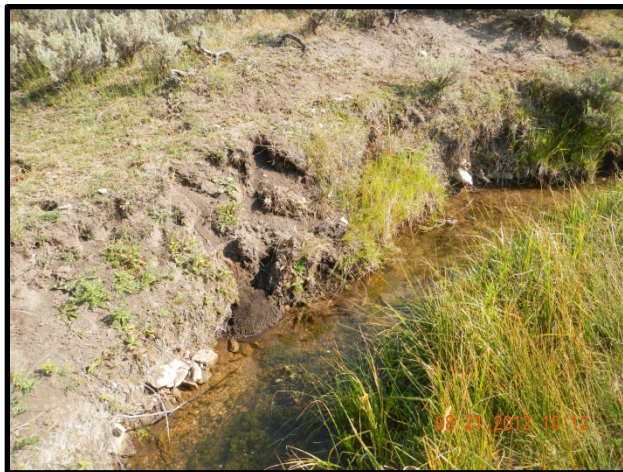
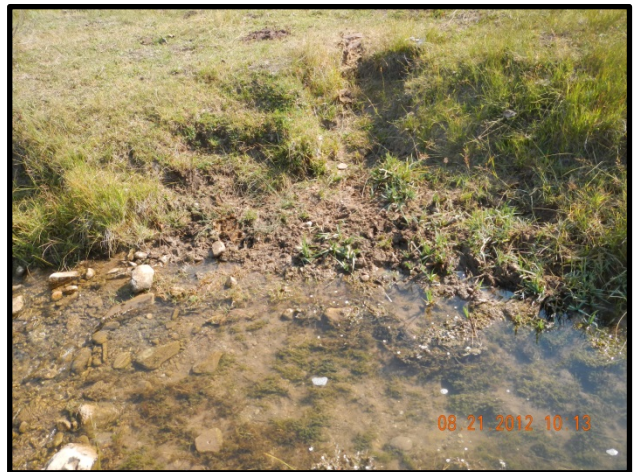
White Dugway Creek—examples of unstable and trampled streambanks.

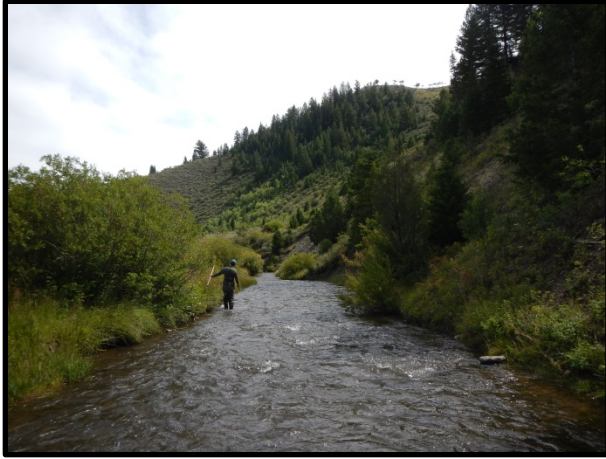
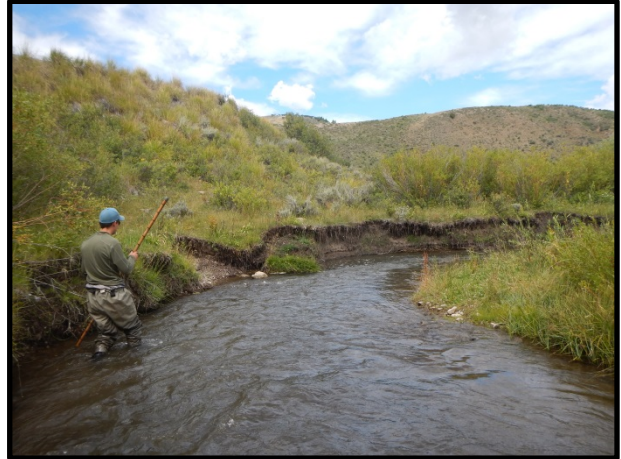
Crow Creek—examples of bank conditions within reach surveyed.

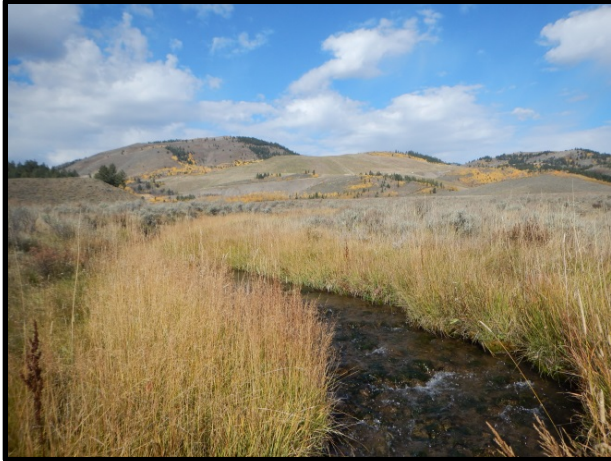
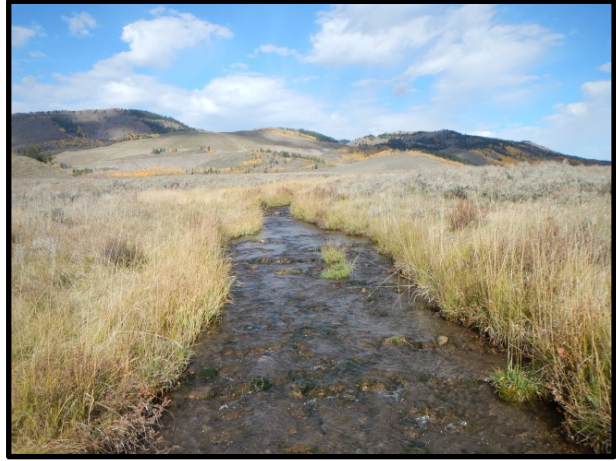
Sage Creek—examples of bank stability conditions within reach surveyed.

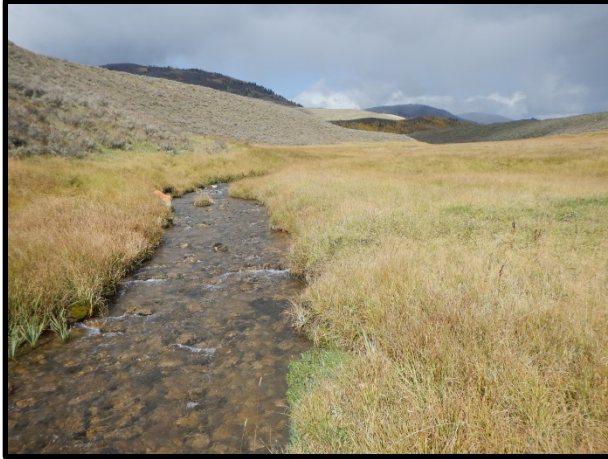
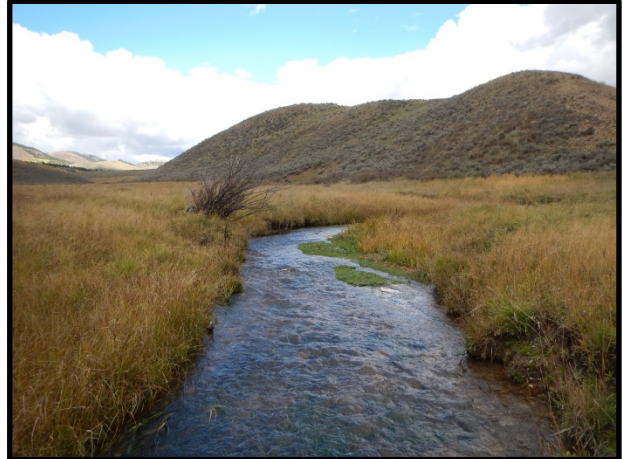
South Fork Sage Creek—examples of bank stability conditions within reach surveyed.

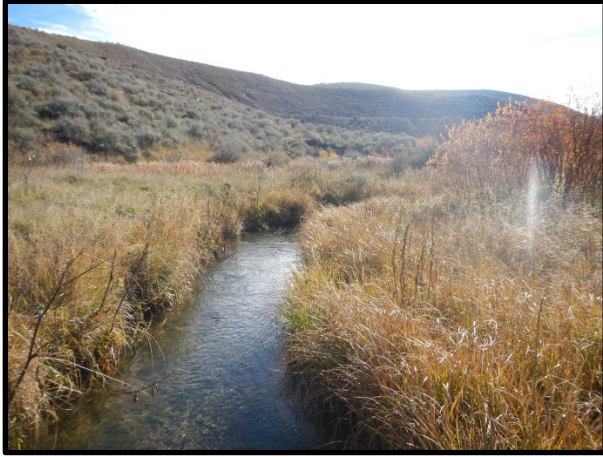
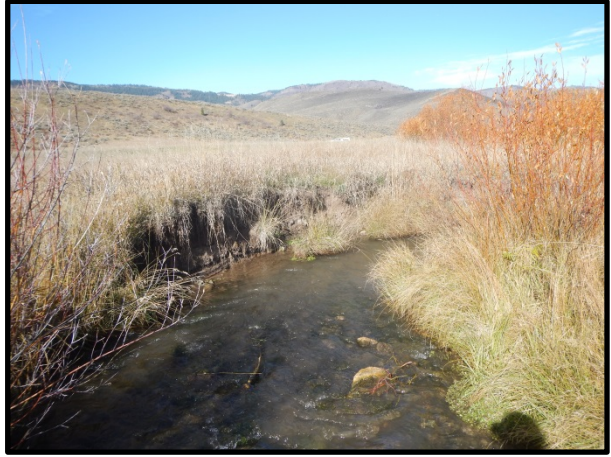
Rock Creek—examples of bank stability conditions in reach 1.

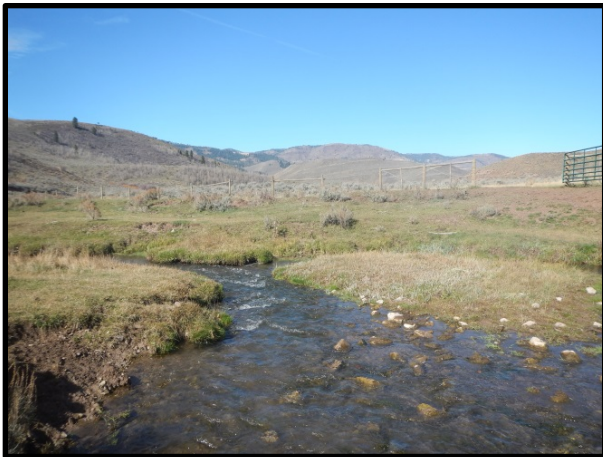
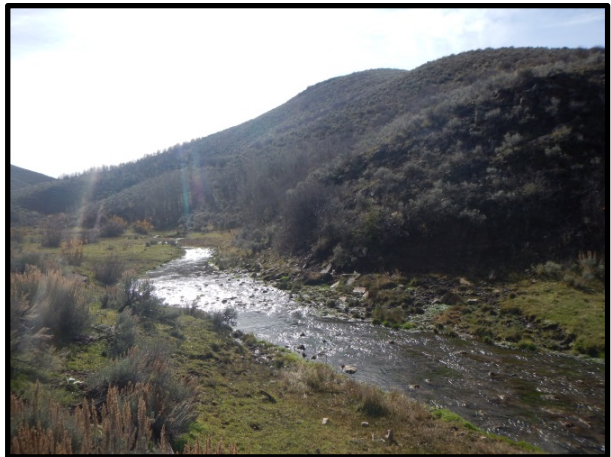
Rock Creek—examples of bank stability in reach 2.

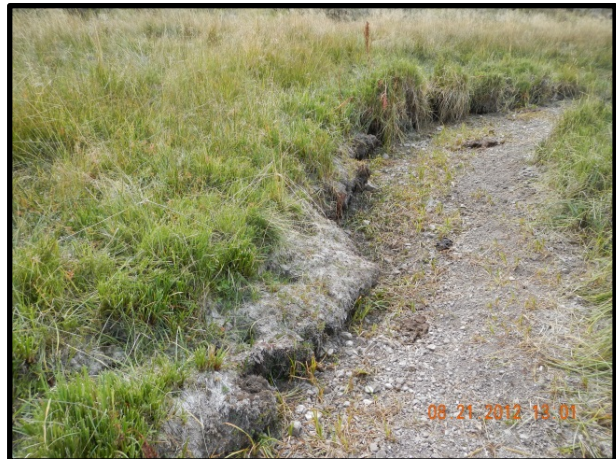
Little Elk Creek—examples of trampled (left) and slumping (right) banks.

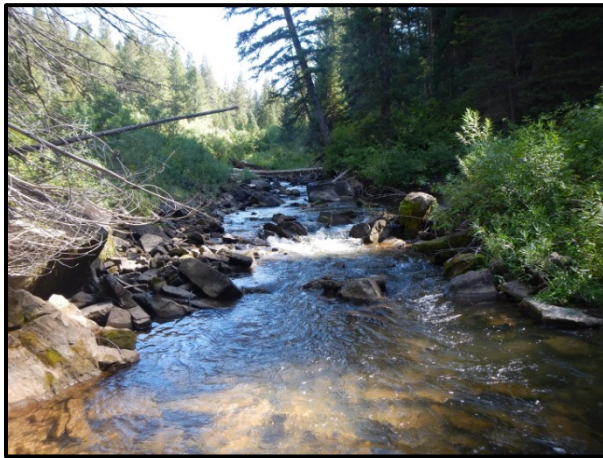
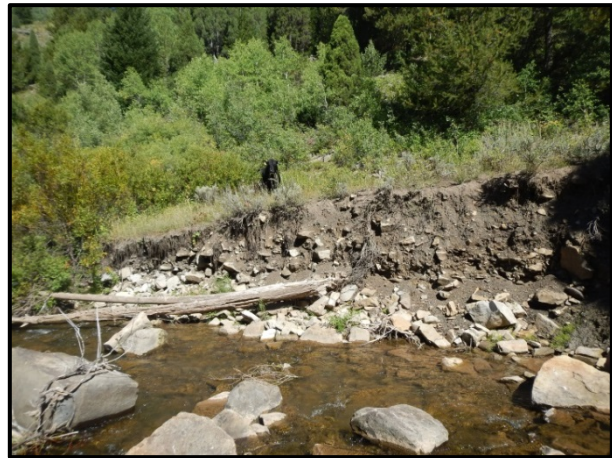
Representative photos of Tincup Creek ID17040105SK003_02

Andrew Kirsch and Hannah Harris visited Tincup Creek to complete sediment cores. Meadow floodplain in upper reach with beaver activity (dams, lodges). Trampled by cows. Many cutthroat observed. Pools filled with fine sediment, algae, and macrophytes. Meadow drains to steep step-pool mountain stream with predominately large cobbles and boulders that are highly embedded with fine sediments. No spawning habitat within SEI reach. Meadow influenced by beaver and in step-pool area sediments are too large for trout spawning. Bald eagle observed. Spruce, Douglas fir forest with riparian of dogwood and willow (especially willow in meadow). Area below SEI reach also contains no spawning habitat. Substrate is too large and blocky for salmonids to move.

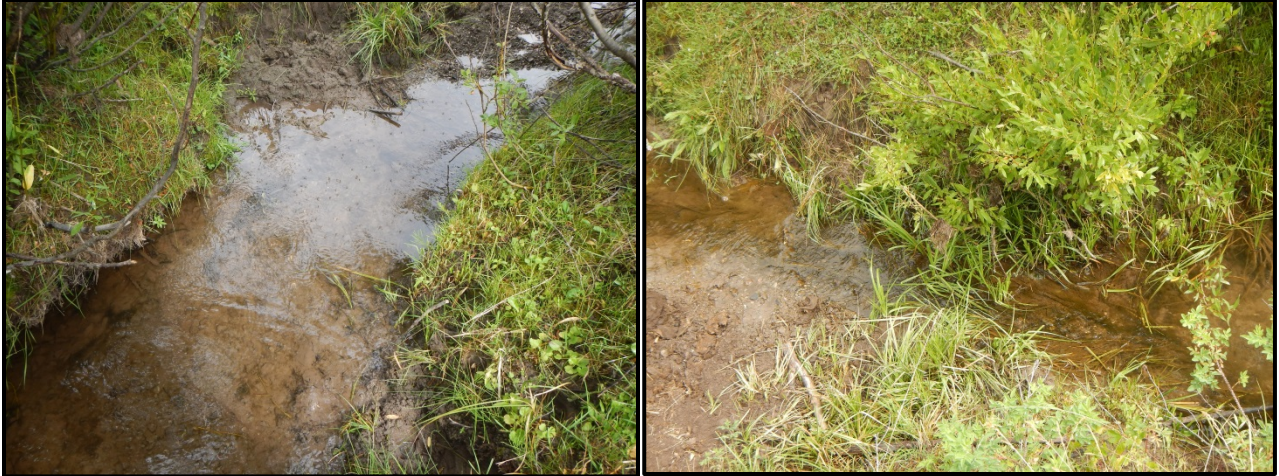
Representative photos of Haderlie Creek ID17040105SK003_02j

Aubree Thomas and Andrew Kirsch visited Haderlie Creek to complete sediment cores. No salmonid spawning habitat was observed on the Forest land where the SEI was completed. Water was low and fine sediments were abundant.

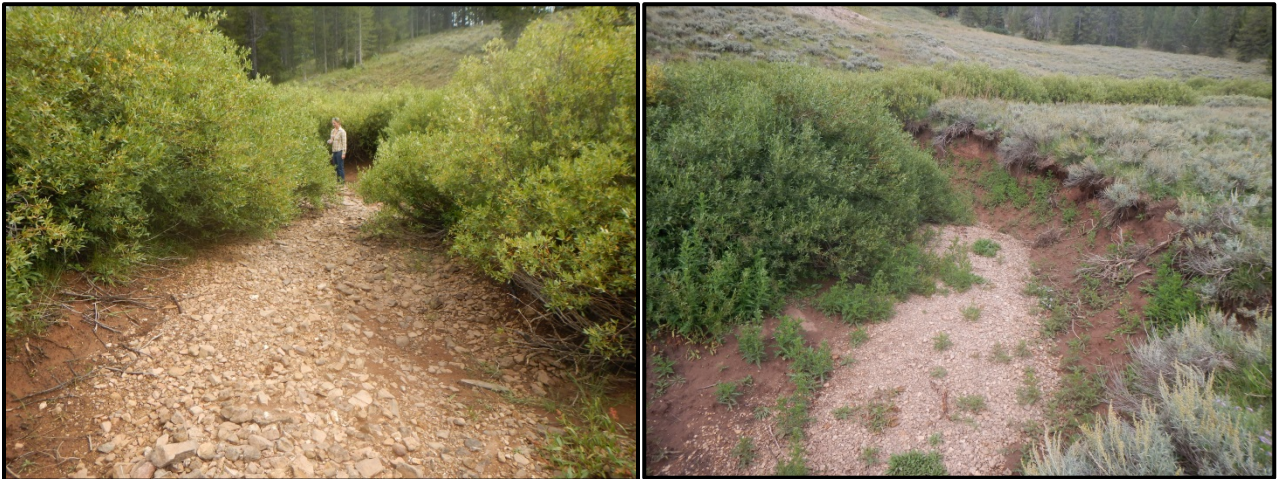
Representative photos of Upper Boulder Creek ID17040105SK006_02c

Andrew Kirsch and Hannah Harris visited Upper Boulder Creek to complete McNeil sediment cores. No spawning habitat because creek is dry except for some small low spots. Lots of willows surrounding a large dry channel. Red soil.

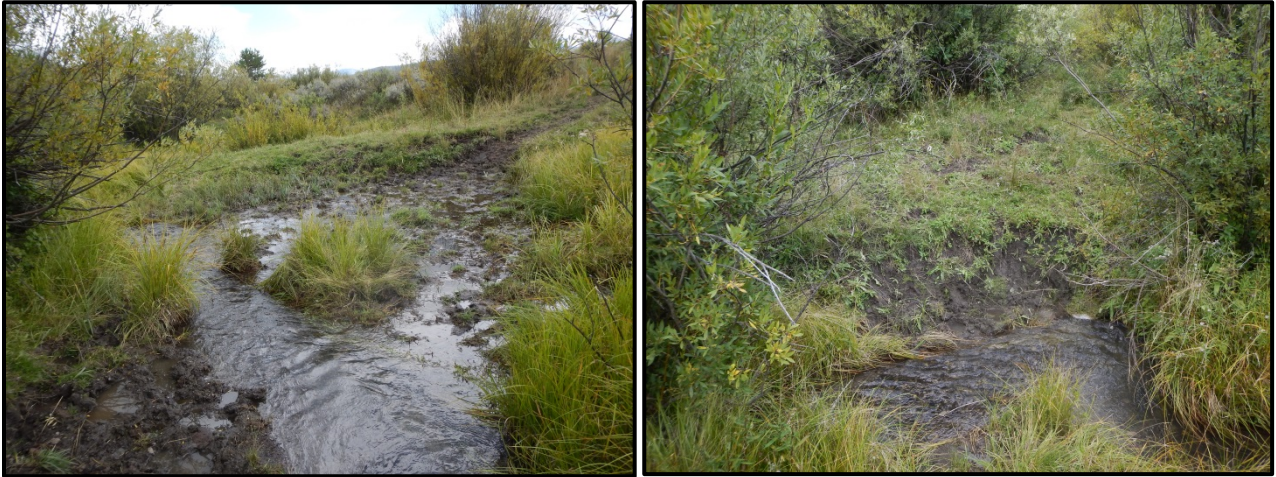
Representative photos of Smoky Creek ID17040105SK007_02c

Andrew Kirsch and Hannah Harris visited Smoky Creek to complete sediment cores. In upper reach, beaver complex with lots of side channels. In lower reach, riffle dominated but not enough water for spawning. No pools. Lots of muddy banks and cow trails and trampling. Lost my sandal in the muck. No spawning habitat. Area is near Smoky Canyon Mine. Can see mountain top removed upstream.
